Tower Alert

To: Tower Owners and Contractors
From: Matthew Arps, General Manager – ANCHORGUARD, LLC
2224 E. 39th St. N., Sioux Falls, SD 57104, 605-331-6426, matthew@anchorguard.com
Date: 31 August 2005
Re: Tower Collapse Due To Anchor Corrosion

Tower Collapse Due to Anchor Corrosion

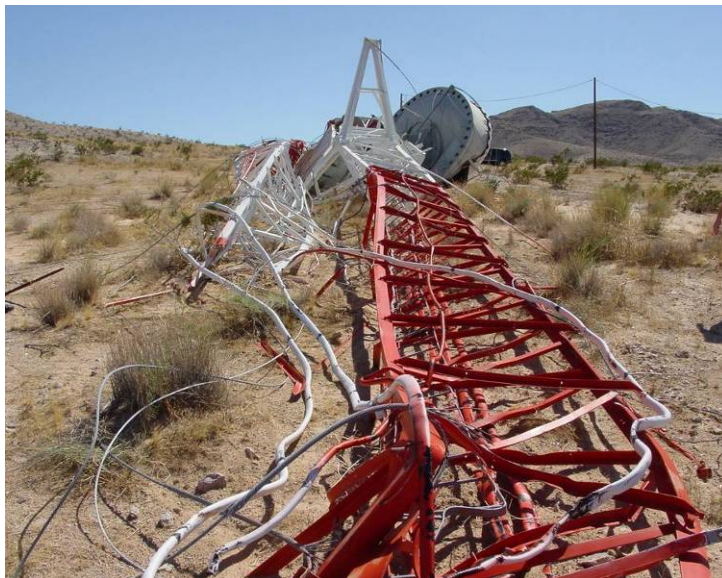
Recently a tower in San Bernardino County, CA collapsed due to guy anchor failure. Further investigation uncovered other towers with severely corroded anchors in Riverside County, CA; La Paz County, AZ; & Maricopa County, AZ. We felt it necessary for life-safety and asset protection to inform tower owners of this problem.

August 2005 - The collapsed tower in San Bernardino County, CA.

- A. Perform an underground investigation of the anchors to the concrete block to determine if structural damage has occurred. The condition of the anchor shaft 12 inches below the ground (the typical depth for most current inspections) is not an accurate predictor of the level of corrosion along the entire shaft. View photos below for more detail.
- B. Install a corrosion control system that allows for continuous monitoring such as the one offered by ANCHORGUARD® Corrosion Control System for Tower Anchors (800)-653-3392. www.anchorguard.com
- C. Regularly inspect the corrosion control system to ensure it is working properly.

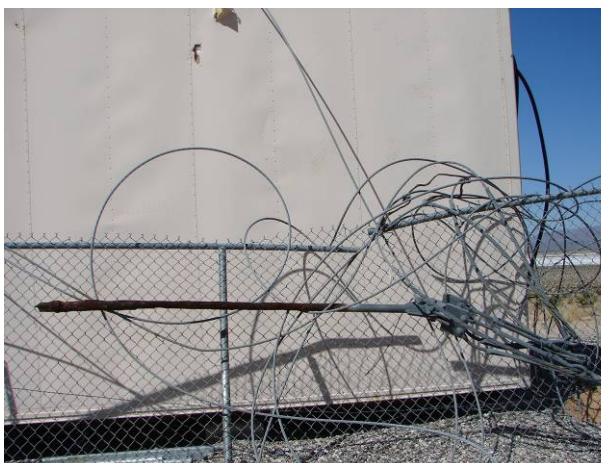
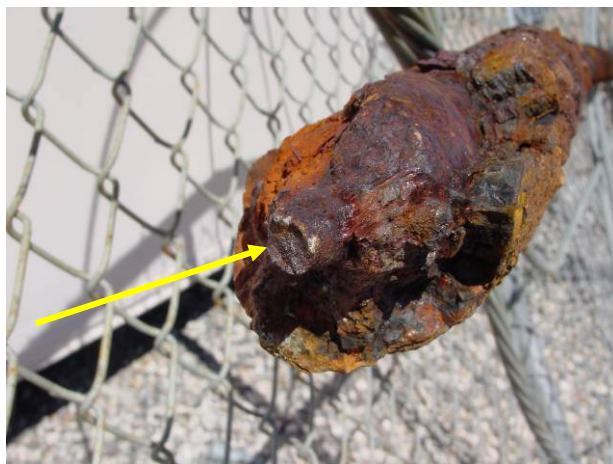
Notice the weakest point was 8 feet below ground level.

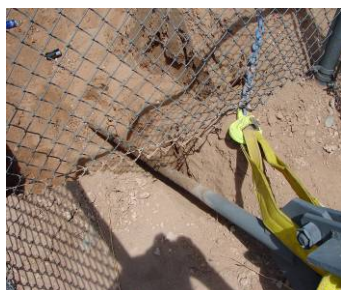
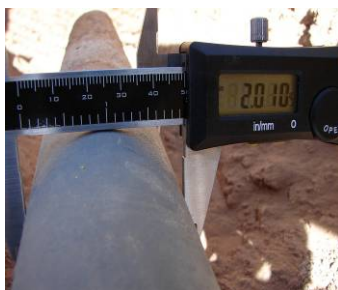
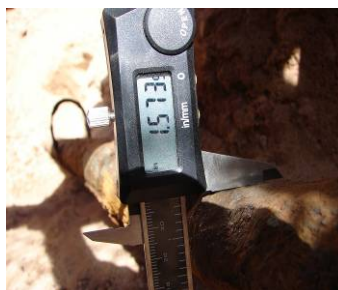
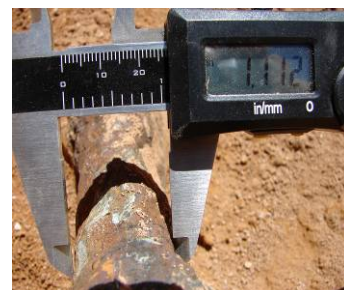
August 2005 - This tower, in Maricopa County, AZ did not collapse. Note that the condition of the anchor shaft at the surface shows no corrosion. Deterioration at two points further down the shaft show significant corrosion.
