Tower Alert

To: Tower Owners and Contractors
From: Matthew Arps, General Manager – ANCHORGUARD, LLC
2224 E. 39th St. N., Sioux Falls, SD 57104, 605-331-6426, matthew@anchorguard.com
Date: 31 August 2005
Re: Tower Collapse Due To Anchor Corrosion

Tower Collapse Due to Anchor Corrosion

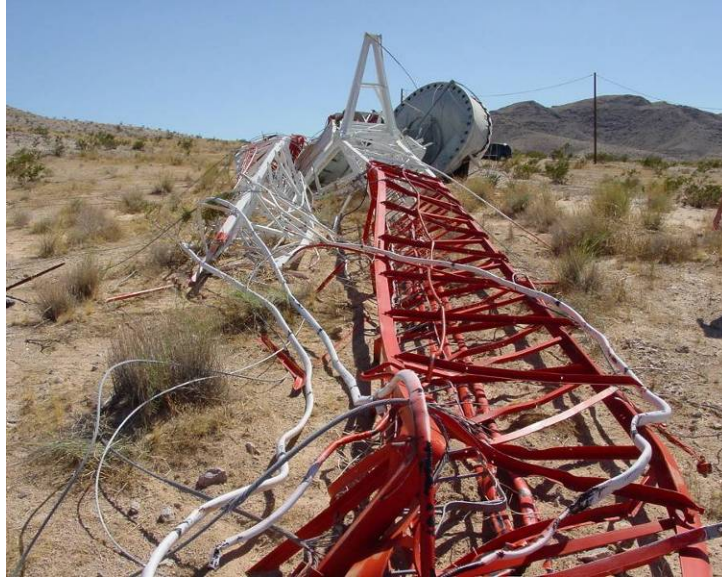
August 2005 - The collapsed tower in San Bernardino County, CA.

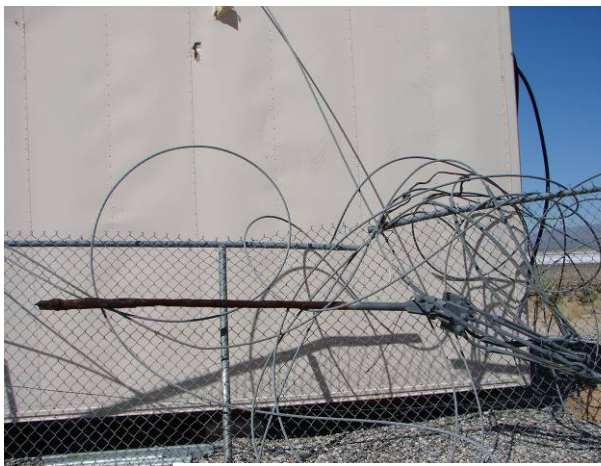
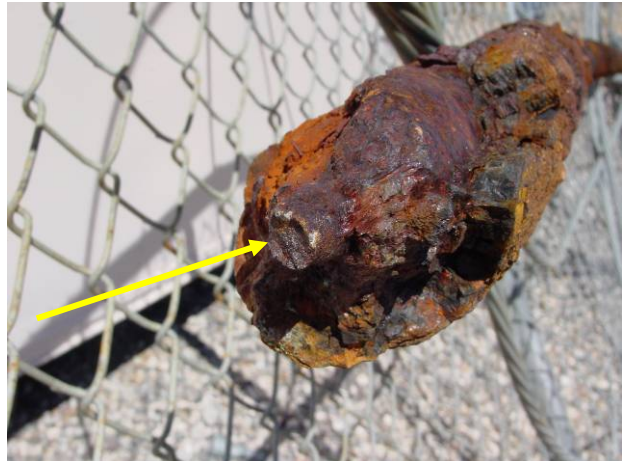
Notice the weakest point was 8 feet below ground level.

- A. Perform an underground investigation of the anchors to the concrete block to determine if structural damage has occurred. The condition of the anchor shaft 12 inches below the ground (the typical depth for most current inspections) is not an accurate predictor of the level of corrosion along the entire shaft. View photos below for more detail.
- B. Install a corrosion control system that allows for continuous monitoring such as the one offered by **ANCHORGUARD**[®] Corrosion Control System for Tower Anchors (800)-653-3392. www.anchorguard.com
- C. Regularly inspect the corrosion control system to ensure it is working properly.

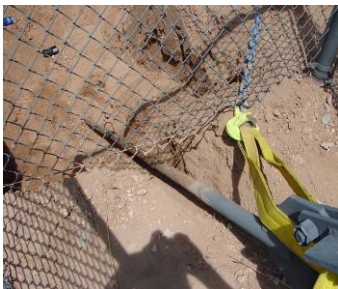
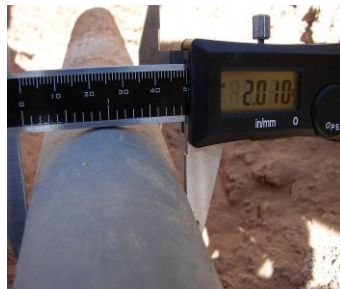
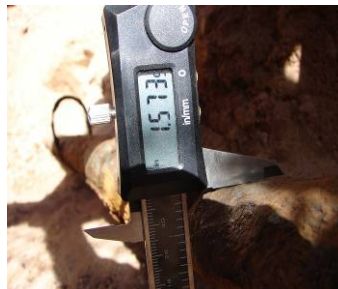
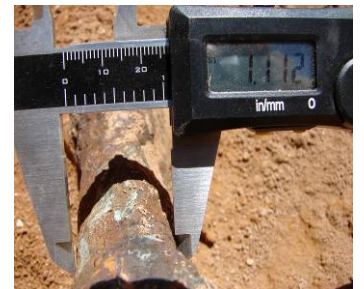
August 2005 - This tower, in Maricopa County, AZ did not collapse. Note that the condition of the anchor shaft at the surface shows no corrosion. Deterioration at two points further down the shaft show significant corrosion.
