Failure is *Not* an Option

Danger to your tower assets may lurk unseen—*below* ground level.

by Shawn Van Giesen

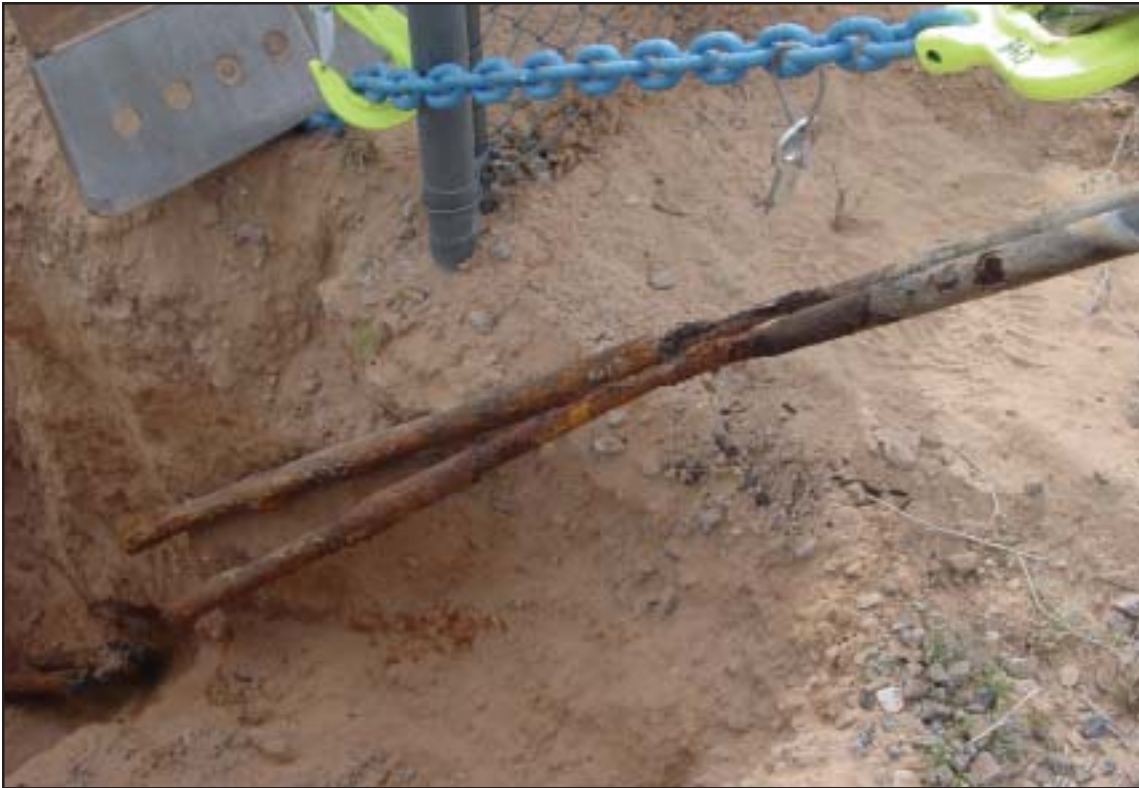
An anchor shaft break that occurred during inspection. The chain visible at the top of the photo was used to secure the guy to a piece of construction equipment as a safety precaution before excavation.

With the sound of a shotgun blast, all the safety chains engaged, the dozer lunged forward and *the anchor failed*.

After checking to see that everyone was OK, a series of preplanned emergency procedures were activated. Midnight found the tower secured by six pieces of heavy equipment and an exhausted anchor investigation team. New anchors were designed and installed with cathodic grounding protection. (Cathodic protection involves the "electrochemistry" alluded to previously. It minimizes the electrical potential in an object or structure either by applying current or by reducing the potential with the nearby placement of a "sacrificial" anode—in simplest terms, a "lightning rod for rust.")

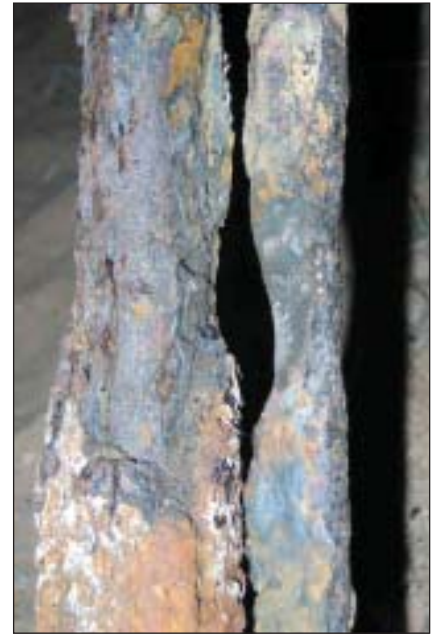
Corroded anchor shaft segments.
