Tower Alert

Anchor Failure Due to CORROSION

OCT. 2004 -- El Centro, California

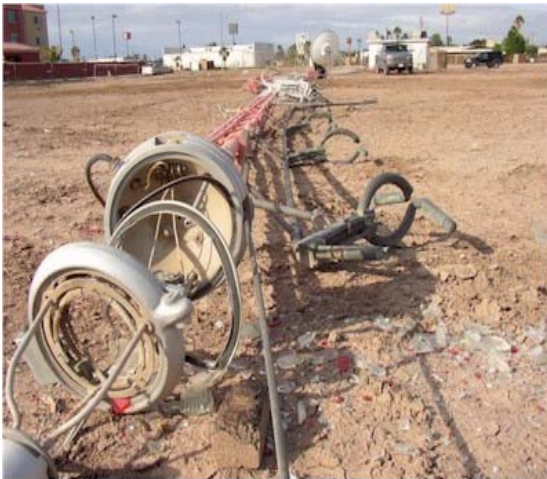
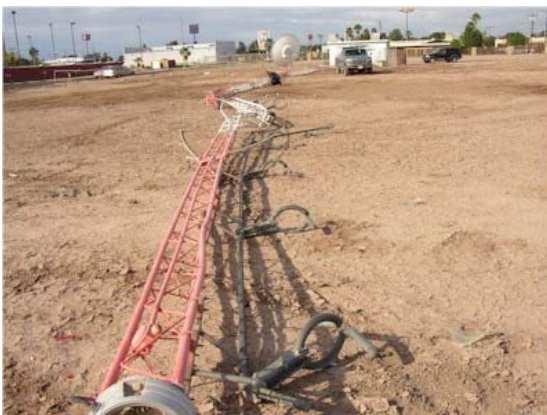
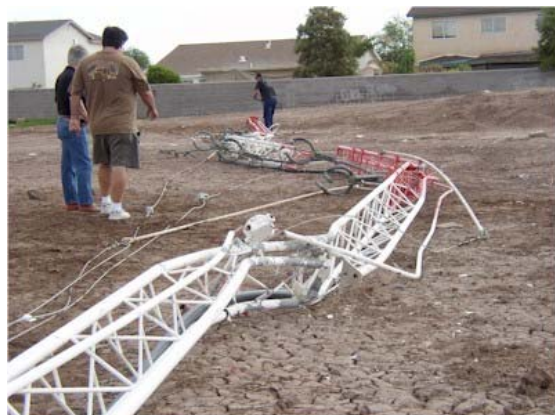
Guy Anchor Corrosion at work again! It seems that the main broadcasting tower for KXO Radio in El Centro, California collapsed; a broadcast engineer reports ***the cause being a guy anchor rusting-through underground from highly corrosive soils.***

AnchorGuard is a corrosion control system for your tower anchors. It becomes the sacrificial anode, taking the place of your anchor in the corrosion cycle and it is very effective in highly corrosive soils. By protecting your anchors you protect your tower investment.
