# Tower Alert

**To:** Tower Owners and Contractors  
**From:** Craig Snyder, President – **Sioux Falls Tower & Communications**  
2224 E. 39<sup>th</sup> St. N., Sioux Falls, SD 57104, 605 331-6972, [snyder@siouxfallstower.com](mailto:snyder@siouxfallstower.com)  
**Date:** 1 February 2005  
**Re:** Anchor Failure Due to Corrosion

## **Guy Anchor Failure Due To Anchor Corrosion**

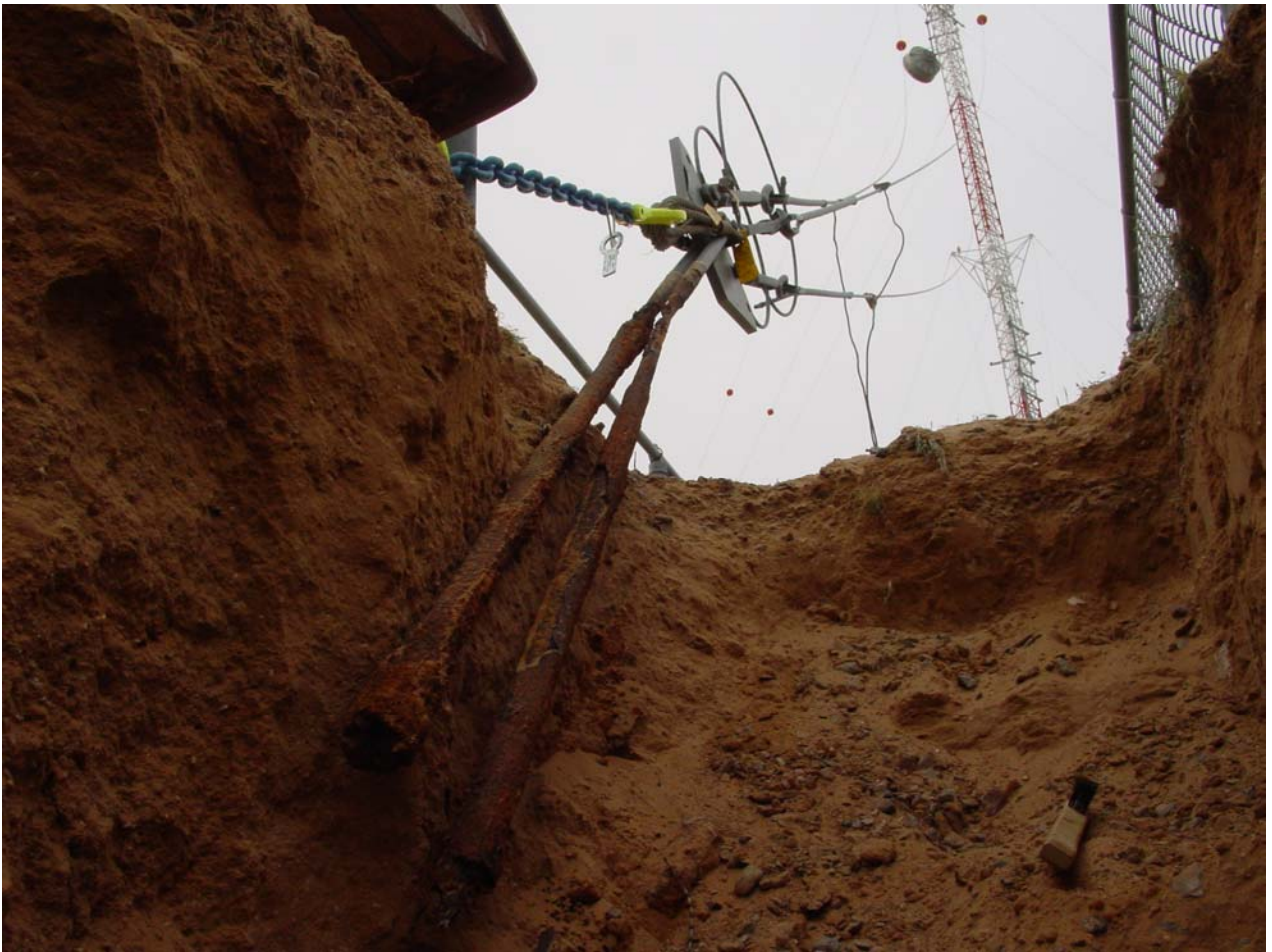
Investigation of guy anchors for corrosion continues to point to the fact that damage due to corrosion can pose a significant risk to towers. Over the past two years, our investigations have found that up to 15% of the towers investigated have structurally damaged anchors that require replacement. A very high percentage of others have significant corrosion but did not require replacement. During a recent subsurface investigation at a site in California, an anchor had diminished to less than ¼" in diameter and ***the anchor failed during the investigation***. It was however attached to a temporary anchorage saving the tower. A similar anchor failure occurred at a separate site six months earlier.

California 1/21/05 – Broken anchor showing slack guy wires

- A. Develop a plan to target towers most at risk for investigation
- B. Perform subsurface investigation of the anchors to determine if structural damage has occurred
- C. Install a corrosion control system that allows for continuous monitoring such as the one offered by **ANCHORGUARD®** CORROSION CONTROL SYSTEM FOR TOWER ANCHORS (800) 653-3392. [www.anchorguard.com](http://www.anchorguard.com)
- D. Regularly inspect the corrosion control system to ensure it is properly working

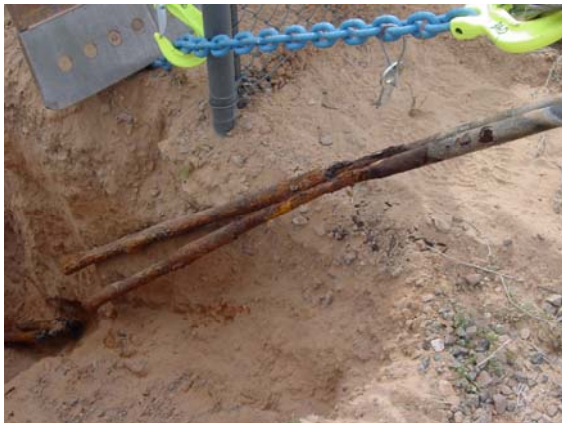
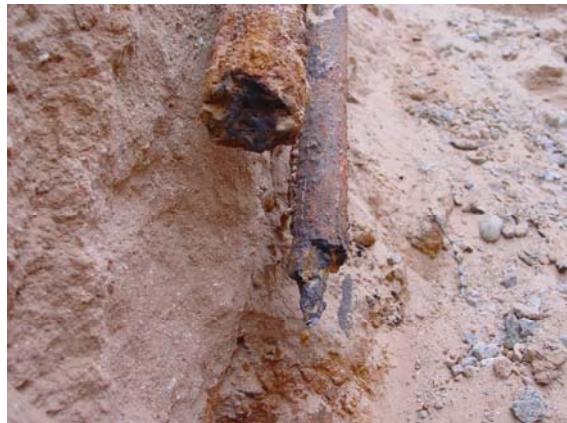
California 1/21/05 – Anchor on temporary chain and close-up of corrosion at break. Note the dry sanding conditions. Dry climates do not preclude active corrosion cells.
