**National Association of Tower Erectors
Chairman's Message
Tower Times
May 2003**

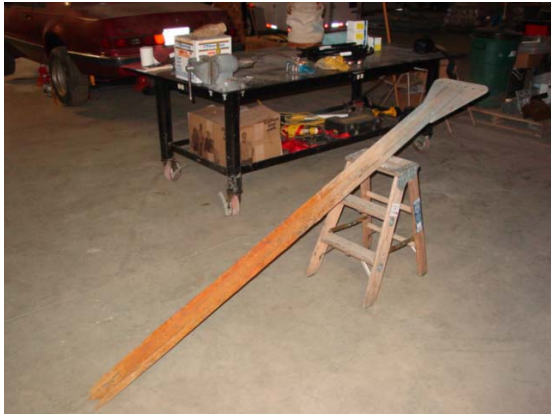
Notice no corrosion until 2' below grade

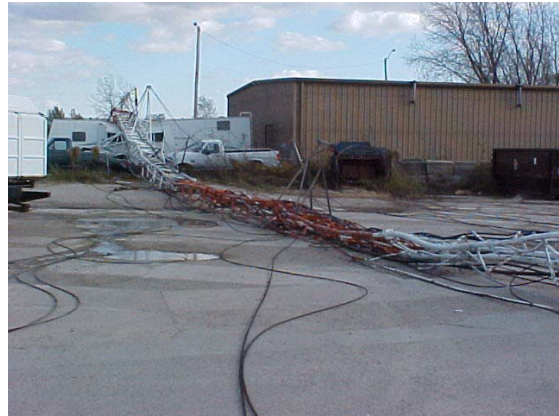
Morton, IL failed tower - 2001

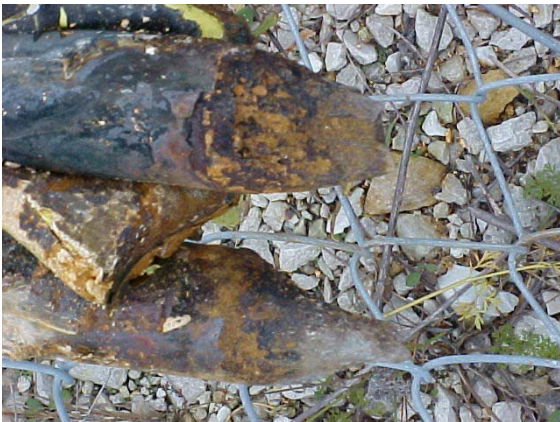
Failed dual anchor shaft – Morton, IL

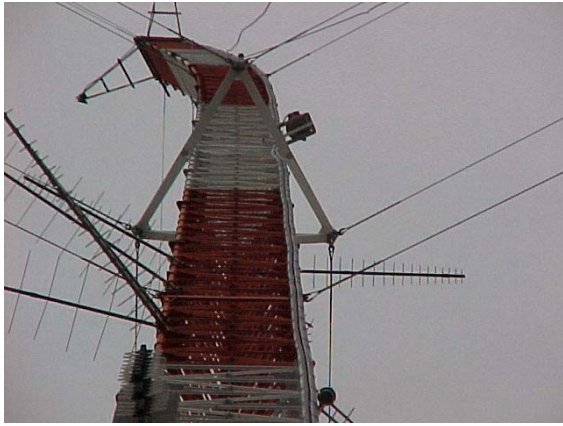
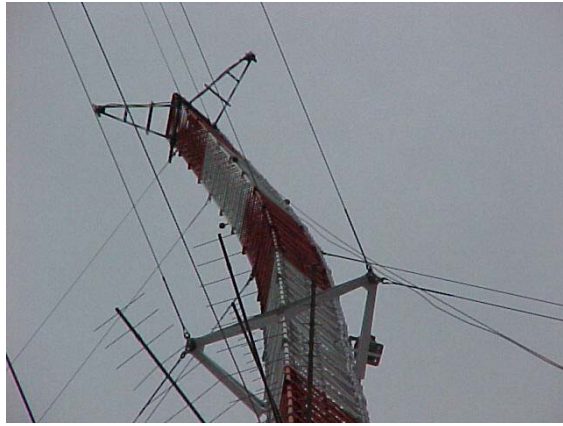
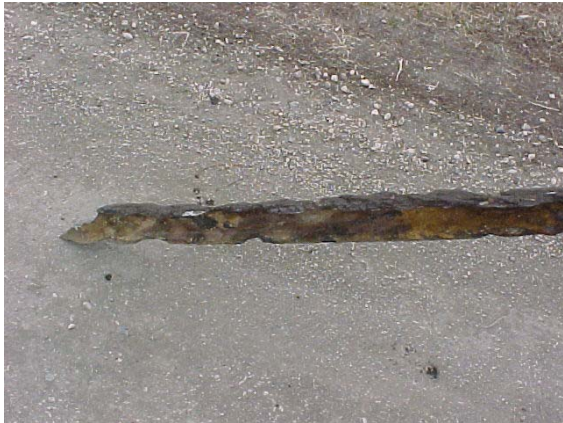
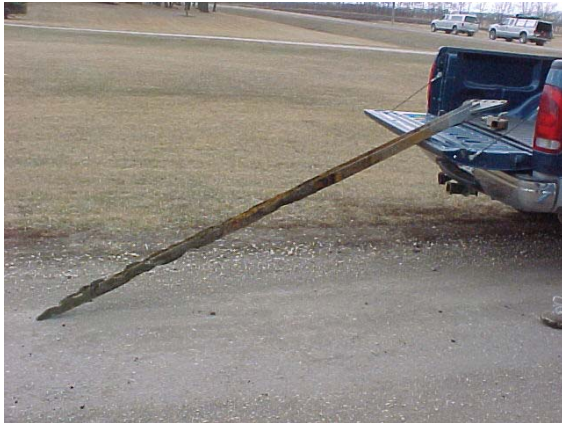
Midwestern United States, March 2003. These pictures are a testimony to the toughness of a guyed tower. Even after the anchor failed holding the top two guy levels although damaged beyond repair the tower remained standing.
