Curiosity That Moved the CAT

By: *Matthew Arps*

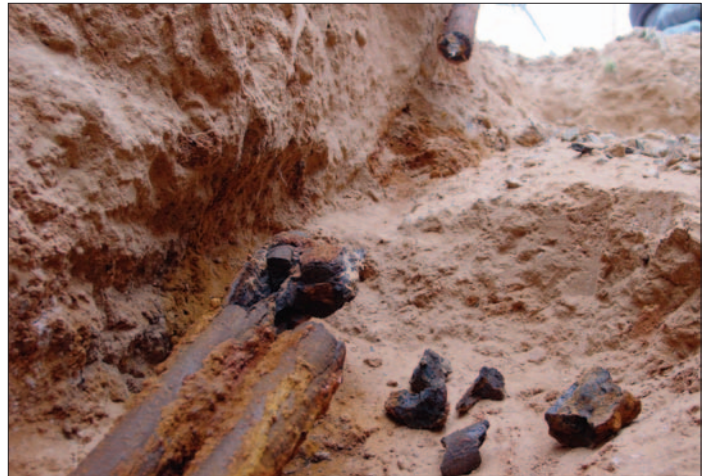
Digging further revealed two anchor rods that had corroded down to approximately 1/4" in diameter. Their original size at the fan plate was 1 1/4", a significant loss. Suddenly, a loud "POP" was heard, and everything sprang into action. The immediate change in tension pulled the tower away from the broken anchor...the tower swayed, the guy wires jerked, and the chain on our CAT became taut!

The springing force was so great it moved our CAT dozer (weighing in at 18,000 lbs.), approximately 4 inches. Without this temporary anchorage, the tower would have toppled to the ground.

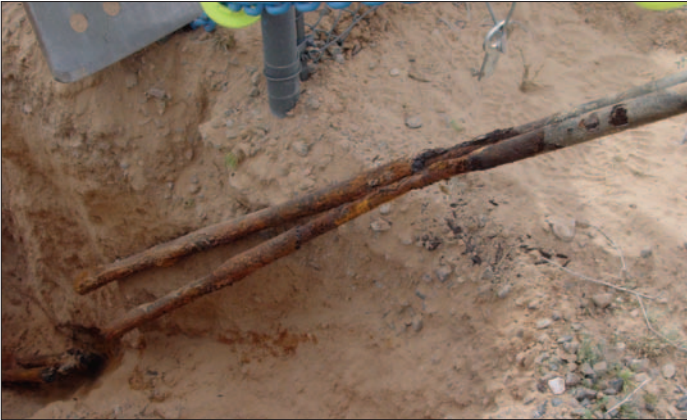
It is becoming increasingly clear that structural damage due to underground corrosion is not an isolated problem, but is widespread throughout the U.S. and Canada. Guy anchors are coming of age and if not inspected and protected soon, many more tower anchors are likely to fail.

- Develop a plan to target towers most at risk, and investigate;
- Perform surface and subsurface investigation of the anchors to determine if structural damage has occurred;
- Install a corrosion control system that allows for continuous monitoring such as a sacrificial anode system; and
- Regularly inspect the corrosion control system to ensure it is working properly.
