TECHNICAL BULLETIN

September 2005

Tower Failure from Anchor Corrosion

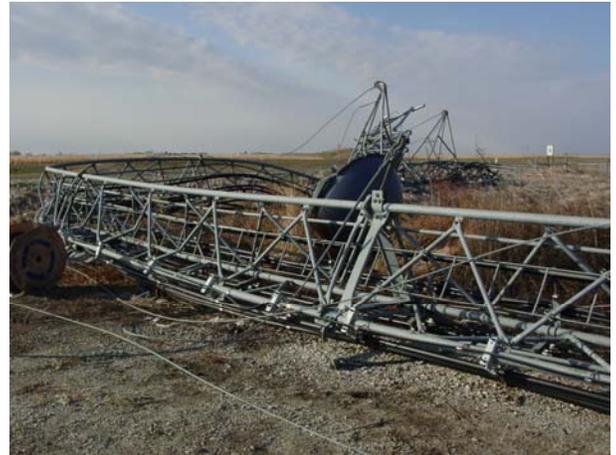
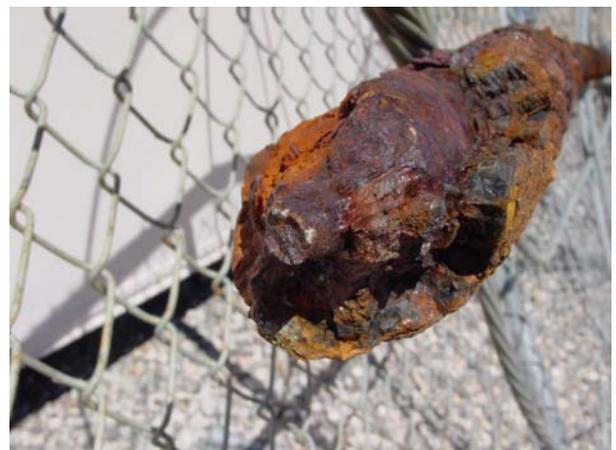
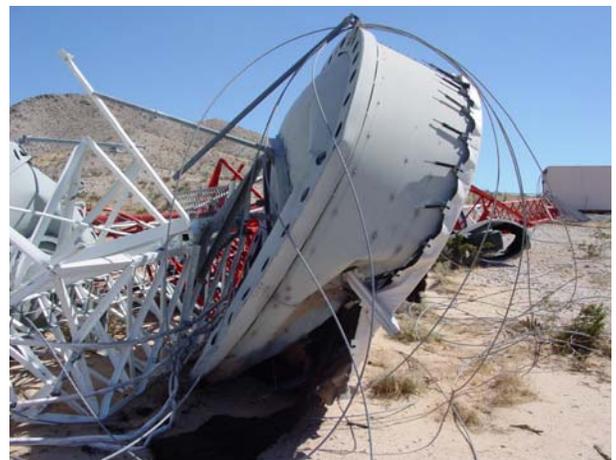
Failed Anchor – August 2005, California

At 7 a.m. on Nov. 2nd 2003 a 180-foot, guyed tower collapsed in winds of less than five miles per hour, falling across a state highway. An audit crew had been climbing on this tower just a few months prior and had reported the above ground structure to be in “good condition.”

Structural analysis revealed the tower was only at 70 percent of its design load. What happened? An anchor failed due to advanced corrosion six feet below grade.

AnchorGuard, with the assistance with PB Telecom, investigated the site revealing that the north guy anchor shaft had corroded to a thickness of less than half an inch, a discovery that has implications for many guyed tower owners and operators across the United States

The tower pictured at lower right held twenty-seven T-1 lines and was a key link in a major microwave backbone network. Estimated cost to tower owner...a couple hundred thousand dollars. Estimated cost to the carrier in lost service/revenue...unknown.

- Develop a plan to target towers most at risk to perform inspections and document the condition of the anchors. Inspections should be done by an experienced contractor.
- Install a corrosion control system to inhibit corrosion on both new and existing structures.
- Regularly monitor the corrosion control system.
