Tower Alert

To: Tower Owners and Contractors
From: Craig Snyder, President – **Sioux Falls Tower & Communications**
2224 E. 39th St. N., Sioux Falls, SD 57104, 605 331-6972, snyder@siouxfallstower.com
Date: 1 February 2005
Re: Anchor Failure Due to Corrosion

Guy Anchor Failure Due To Anchor Corrosion

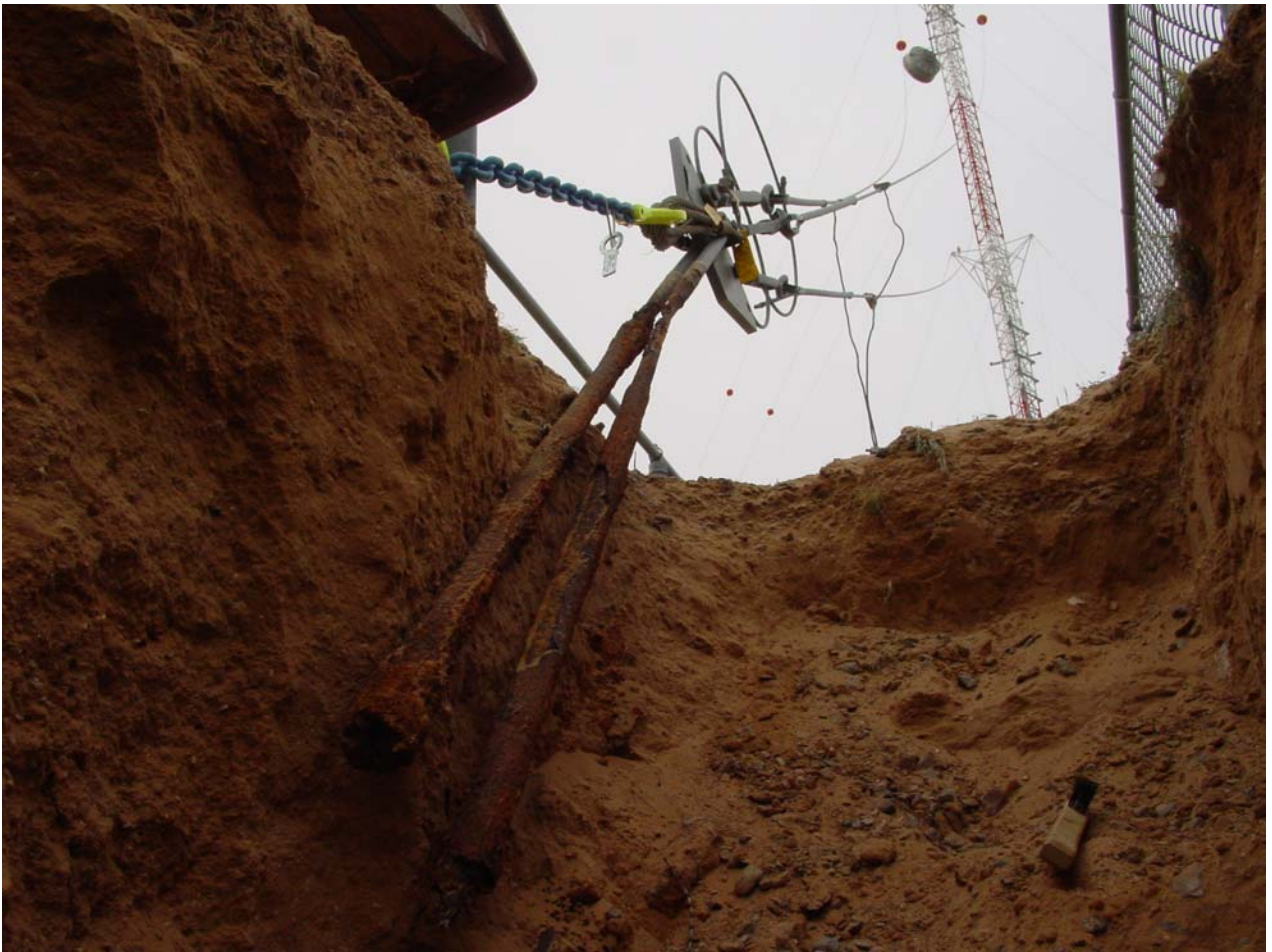
Investigation of guy anchors for corrosion continues to point to the fact that damage due to corrosion can pose a significant risk to towers. Over the past two years, our investigations have found that up to 15% of the towers investigated have structurally damaged anchors that require replacement. A very high percentage of others have significant corrosion but did not require replacement. During a recent subsurface investigation at a site in California, an anchor had diminished to less than ¼" in diameter and ***the anchor failed during the investigation***. It was however attached to a temporary anchorage saving the tower. A similar anchor failure occurred at a separate site six months earlier.

California 1/21/05 – Broken anchor showing slack guy wires

- A. Develop a plan to target towers most at risk for investigation
- B. Perform subsurface investigation of the anchors to determine if structural damage has occurred
- C. Install a corrosion control system that allows for continuous monitoring such as the one offered by **ANCHORGUARD®** CORROSION CONTROL SYSTEM FOR TOWER ANCHORS (800) 653-3392. www.anchorguard.com
- D. Regularly inspect the corrosion control system to ensure it is properly working

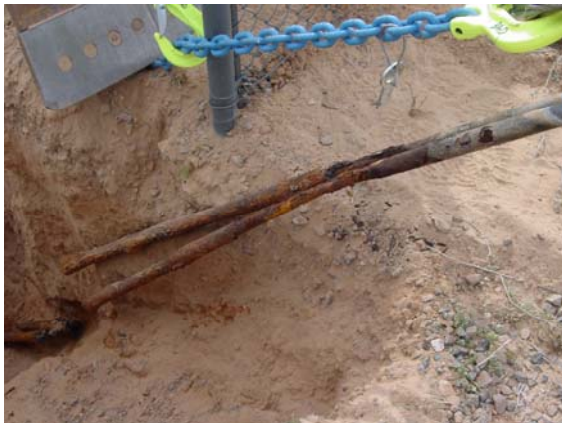
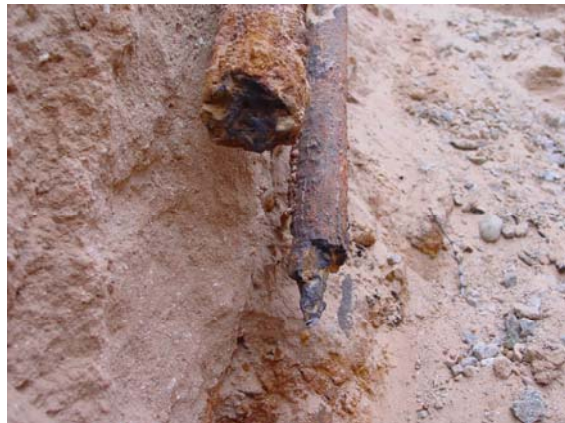
California 1/21/05 – Anchor on temporary chain and close-up of corrosion at break. Note the dry sanding conditions. Dry climates do not preclude active corrosion cells.
